Fatality Investigation Report

OR 2013-27-1

Collapsed roof trusses kill carpenter foreman

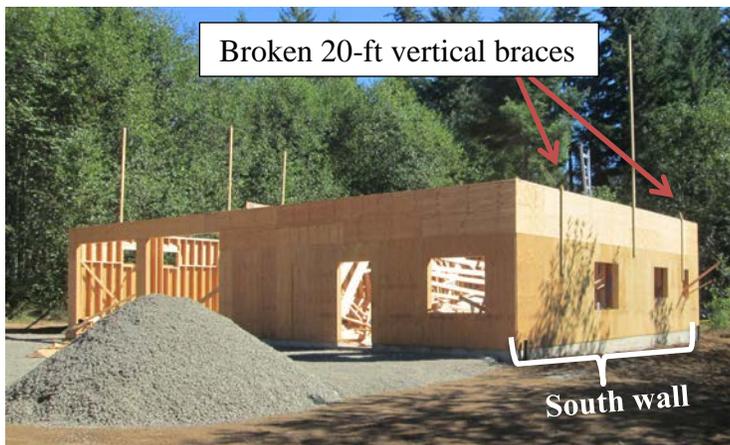
Figure 2. The shop/garage building with collapsed trusses within the structure. Note the 2X4's nailed to the outside of the south wall and that ground bracing was not erected. Middle vertical brace remained unbroken.

On the morning of the incident, two workers arrived at the job site for the first time. The crew completed the framing of the interior wall that would separate the garage from the shop. At the south end of the structure the crew nailed three 20-foot long 2X4's to the outside of the south wall (see Figure 2). Contrary to the Structural Building Components Association, BCSI-B1

Summary Sheet (see Figure 4 and Reference #7) additional diagonal external or internal ground bracing was not installed along the south wall, the gable end. One worker explained in his recorded interview that the practice he observed on the job was consistent with his experience on similar jobs.

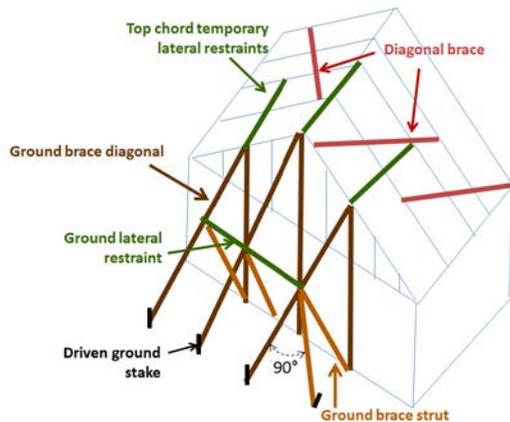
Figure 4. Recommended bracing schematic 1. Adapted from diagrams in BCSI-B1 Summary Sheet-Guide to Handling, installing, Restraining and Bracing of Trusses (see Reference #7 for complete information).

was, “brief all members of the erection/installation crew as to the installation plan and the intended lateral restraint and diagonal bracing requirements.” A specific notice (see page 19) warns that, “the use of ground brace verticals alone, attached to the end wall, is not considered good construction practice and is not permitted.”

- The truss manufacturer document, Structural Building BCSI-B1 Summary Sheet (see Reference #7 and Figure 4 below for recommended bracing) provided upon delivery, warned of potential collapse if improperly handled, erected, installed, restrained or braced. Evidence from pictures taken immediately after the incident and from recorded interviews and discussion with the OSHA inspector confirmed that adequate bracing was not installed and a bracing plan was not discussed with the crew. Three vertical 2X4’s nailed to the outside of the south wall were used to brace the first gable truss but without ground bracing, struts or restraint (see Figure 5 to view bracing installed on day of incident). The guide specifically states that step 1 for setting trusses is to, “install ground bracing.” Additionally, it recommended diagonal bracing at each end and for each set of four trusses. The BCSI booklet 2013 edition (see Reference #6) provides best practices and includes a checklist for the erection/installation process and safety reminders. Among the BCSI recommendations

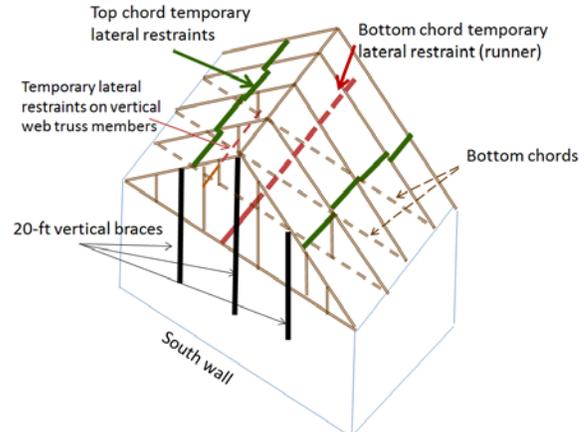
According to the OSHA report and recorded interviews, the crane operator and the worker assisting him, called out to the foreman several times that bracing was inadequate. In response, additional temporary lateral restraint boards were added between the first six east side vertical truss web members and across the first nine west side vertical web truss members but not ground braces or diagonal braces. The process continued until after the 13th truss was set in place. The foreman disconnected the truss from the rigging. As the rigging cleared the truss by approximately one foot, the crane operator and the worker on the trailer saw the trusses falling and tried to warn the crew.

Figure 5. Implemented bracing schematic 2. This schematic represents the braces and restraints believed to have been installed by the crew on the day of the incident.
