# Safety Bulletin

U.S. Chemical Safety and Hazard Investigation Board

## MANAGEMENT OF CHANGE

No. 2001-04-SB | August 2001

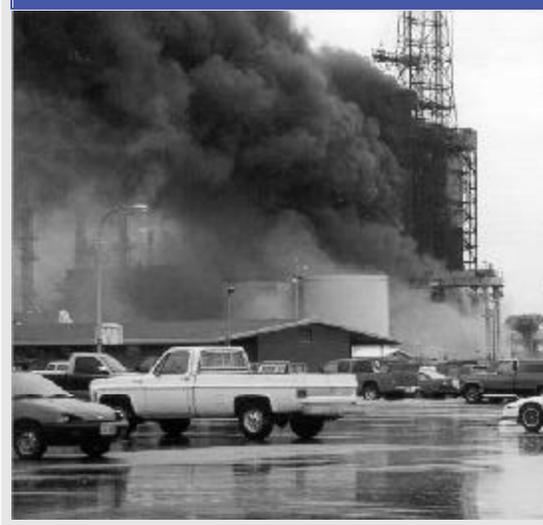
On November 25, 1998, a fire at the Equilon Enterprises oil refinery delayed coking unit in Anacortes, Washington, caused six fatalities (Figure 1). A loss of electric power and steam supply approximately 37 hours prior to the fire had resulted in abnormal process conditions.

● Figure 1. Equilon Enterprises oil refinery fire.

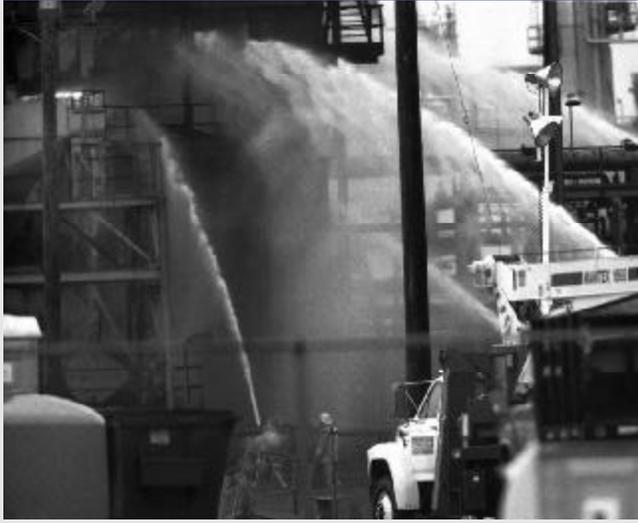
The top head was unbolted and lifted from the drum. The bottom head was also unbolted and held in place by a hydraulic dolly. The operator then activated a release mechanism to lower the dolly. Witnesses reported hearing a whooshing sound and seeing a white cloud of vapor emanate from the bottom of the drum. The hot petroleum vapor burst into flames. The process supervisor, an operator, and the four contract personnel assisting were caught in the fire and did not survive (Figure 2).

● Figure 2. Fire control efforts at Equilon refinery.

After the incident, Equilon relocated the controls for the hydraulic dolly to allow workers to position themselves farther from a drum when opening it.

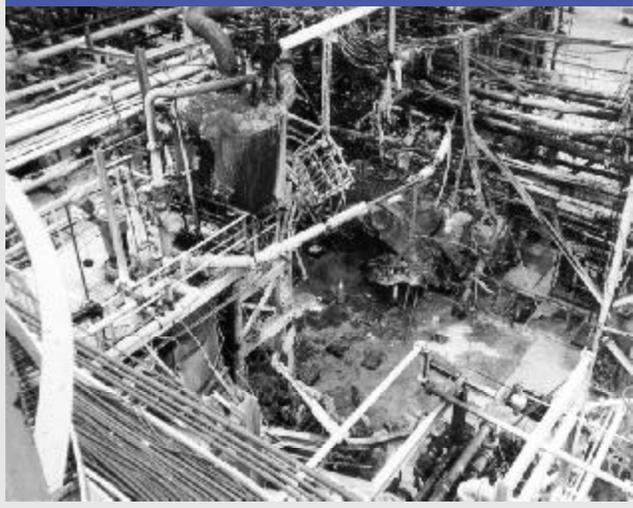
On October 13, 1998, a reaction vessel explosion and fire at the CONDEA Vista Company detergent alkylate plant in Baltimore, Maryland, injured four people (Figure 3).

When the process was shut down for maintenance, the operators were unable to empty the liquid that remained in the reactor. Sludge had settled in the vessel, plugging the bottom outlet nozzle.

● Figure 3. Site of ruptured reactor, CONDEA Vista Company detergent alkylate plant.

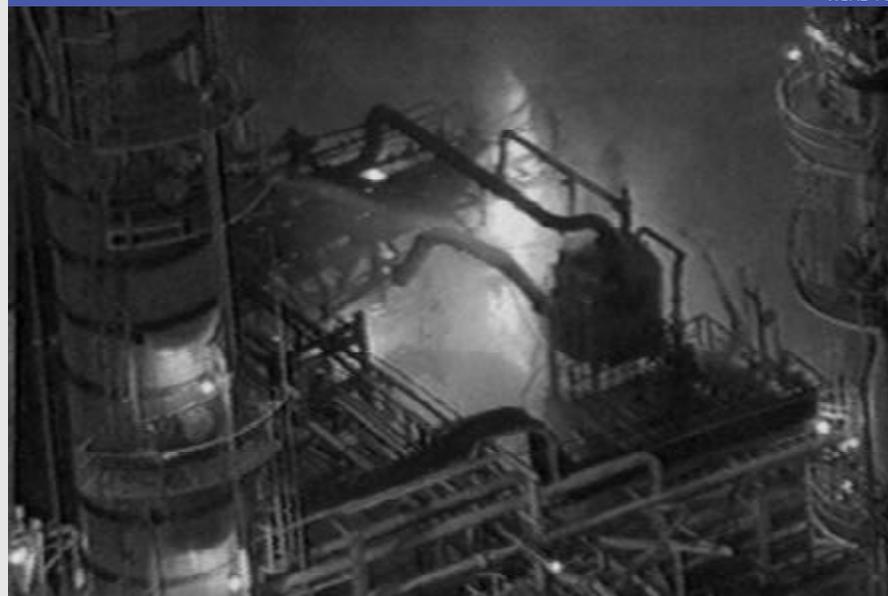
The night shift supervisor instructed an operator to add steam to the reactor. Minutes after the operator started to continuously inject the steam, it reacted with the metallic aluminum and the aluminum chloride residue in the sludge. The reactor vessel exploded (Figure 4).

From both a project and an operational standpoint, the incident at CONDEA Vista emphasizes the importance of systematically managing changes. Post-incident investigations noted that the density of the new catalyst (powdered aluminum) was higher than that of aluminum chloride. The higher density material—combined with problems related to initial overfeeding of the aluminum—overtaxed the mixing capability of the agitator and allowed aluminum to settle in the bottom of the reactor, where it plugged the lower nozzle and accumulated as sludge.

● Figure 4. CONDEA Vista plant fire.
