# NJ FACE INVESTIGATION REPORT

FACE 13-NJ-015

## Laborer Dies after Falling Through 40-Foot High Roof of Recycling Facility

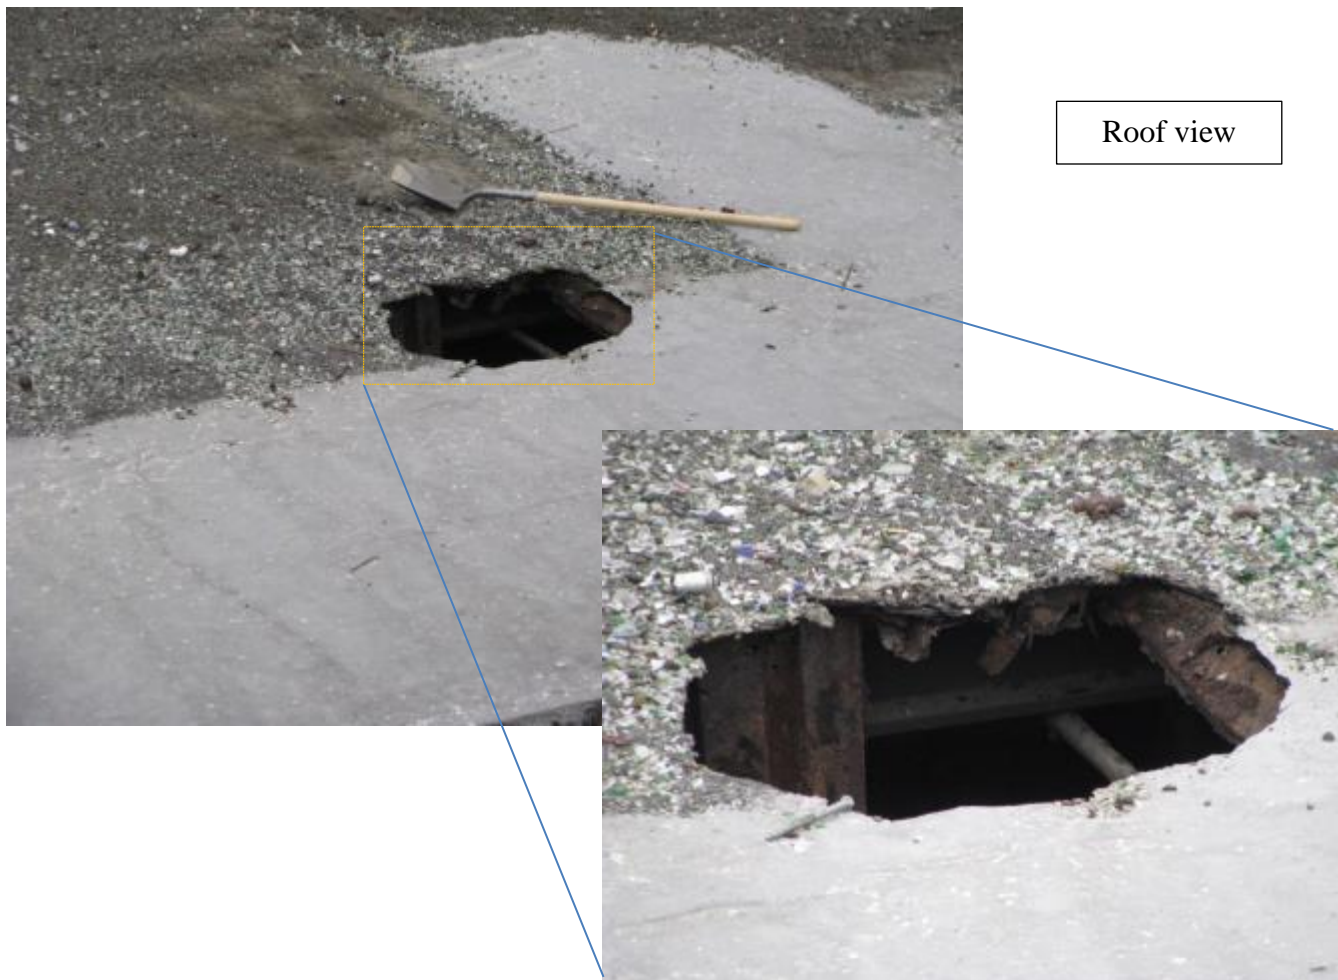
A 50-year-old male laborer fell through the roof of a large recycling facility. The incident occurred on a flat roof approximately 40 feet above the floor of the recycling plant. The victim fell 30 feet and hit an air compressor on a raised platform (approximately 10 feet off the ground). On the day of the incident, the victim and two other workers were assigned to clear a layer of stones that was in place to protect the roof from ultraviolet light damage. The workers were using brooms and shovels to load the stones into wheelbarrows, which were taken to the edge of the roof and dumped to a dumpster below. The victim stepped on an area of the roof that failed and fell to his death.

**FIGURE 3. Close up of roof where victim fell.**

**Discussion:** According to OSHA's fall protection standard (29 CFR 1926.501), any walking or working surface should be structurally sound, and employees should only be allowed to walk/work on surfaces that can support their weight.<sup>1</sup> In this case, the roof where the workers were clearing stones had areas where the steel decking had rusted/deteriorated. A thorough inspection of the roof from the inside may have revealed the issues with the underlying metal roof deck. The damaged areas may only be detectable through visual inspection from the inside of the building. In addition, water invading through deterioration at specific points can travel across beams/joists and drip to the ground in different locations. NJ FACE recommends developing a roof inspection checklist, and/or hiring a roofing expert to conduct a thorough investigation. An example of a roof inspection checklist can be found at the following: <http://www.gcr1.com/fpc/checklist.pdf>.

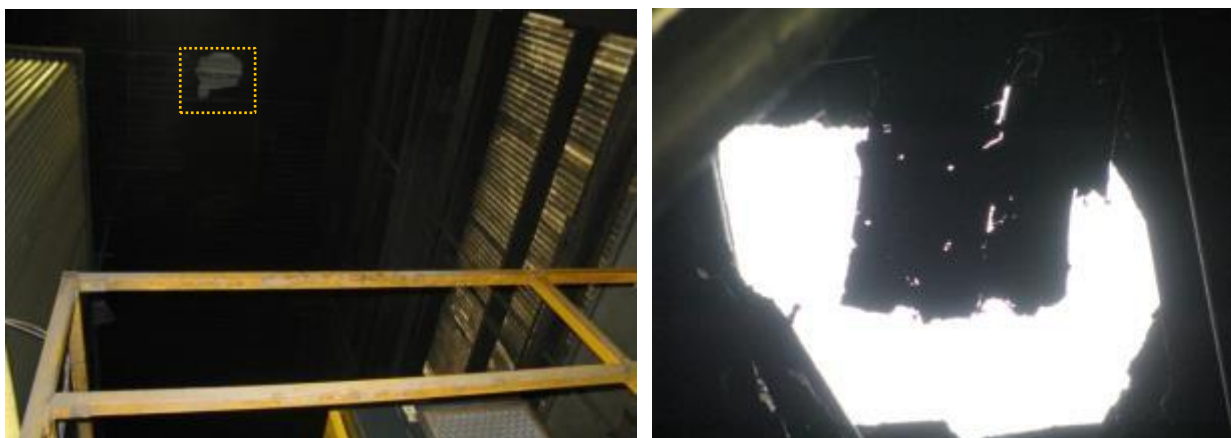
**FIGURE 4. Pictures from inside plant, underneath where victim fell (left: hole had been repaired since the incident; right: close up of hole on day of incident).**
